Section 7 Results of Fieldwork

7.1 Results of Pedestrian Inspection

7.2 Test Excavation Results

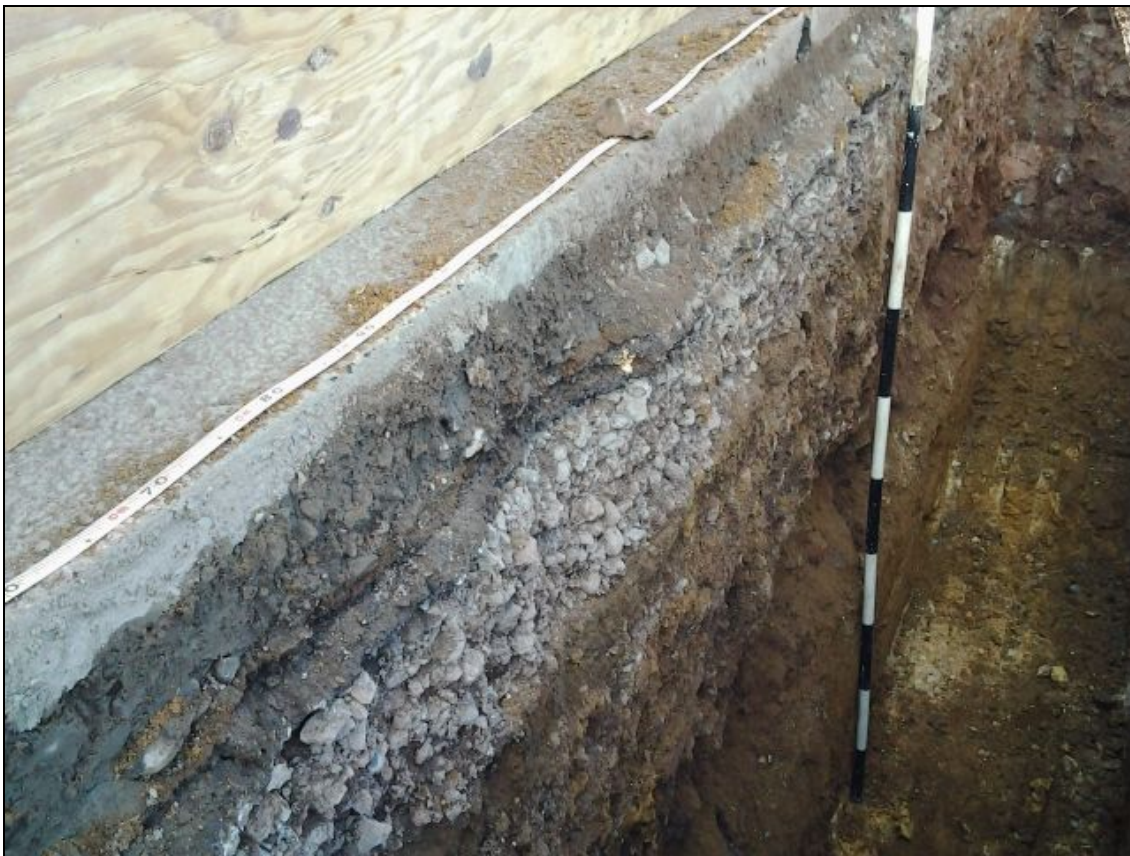
Figure 197. Photograph of Airport Section, T-036, general view of profile, view to southwest

Summary: The stratigraphy of T-036 consisted of two successive asphalt layers and associated base courses (Stratum Ia to Id) overlying fill (Stratum Ie and If) and natural clay (Stratum II) to the coral shelf (Stratum III). Stratum II appears to conform with the USDA soil survey designation of Ewa silty clay loam (EmA). A two-liter bulk sediment was collected from Stratum II in T-036. The sample was wet-screened with no significant results. No cultural resources were reported.

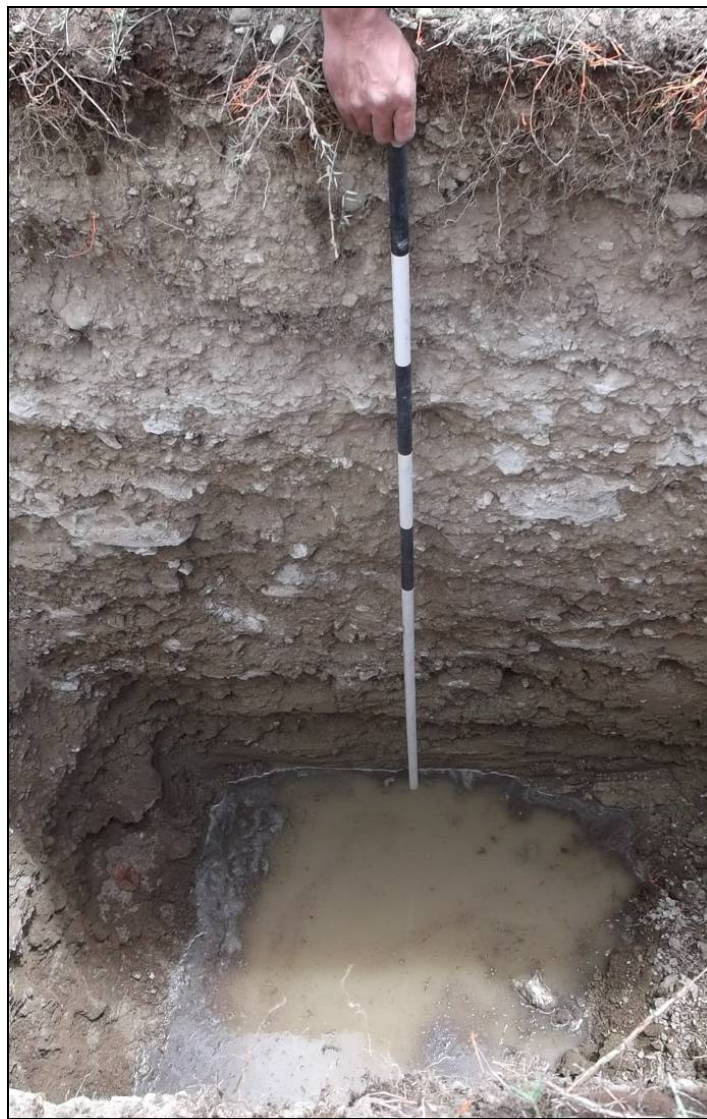
Figure 204. Photograph of Airport Section, T-038, general view of profile, view to southeast

Summary: The stratigraphy of T-038 consisted of fill (Stratum Ia to Ic) overlying naturally deposited gleyed sandy clay (Stratum II) to the water table at 253 cmbs. The stratigraphy generally conforms to the USDA soil survey designation of Fill Land (FL). Wet-screening of a bulk sample of Stratum II yielded small amounts of charcoal, non-midden shell, fish bone fragments, wood pieces, and a rusted metal fragment.

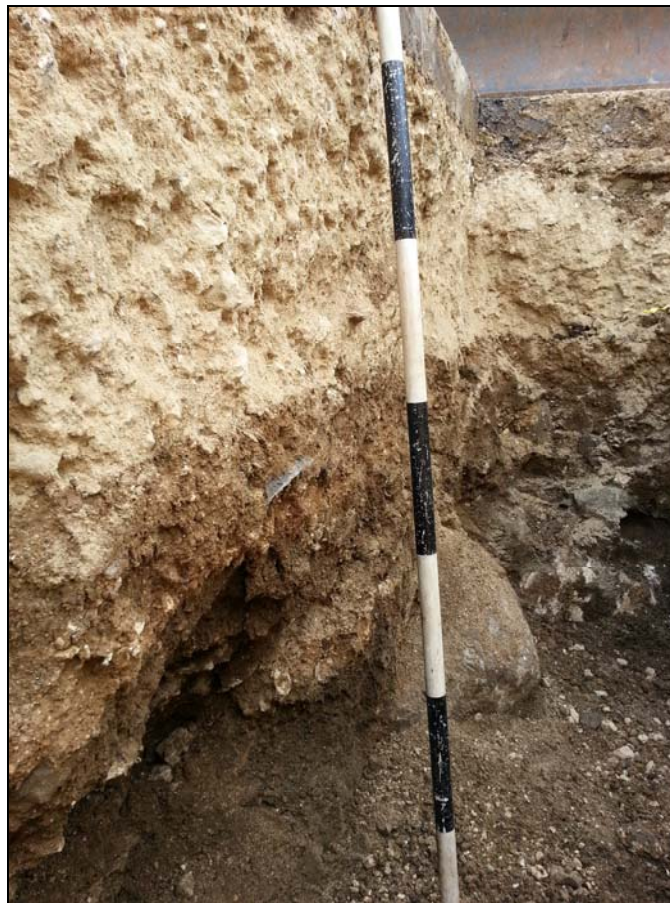
Figure 215. Photograph of Airport Section, T-041, general view of profile, view to northwest

Summary: The stratigraphy was fill (Stratum Ia to Ie) overlying naturally deposited clay (Stratum II) to basalt bedrock (Stratum III). The stratigraphy generally conforms to the USDA soil survey designation of Fill Land (FL). Imported fill events were observed to a depth of 107 cmbs. Bedrock was encountered at 230 cmbs. A 1942 Coca Cola bottle collected from Stratum II indicates that the overlying fill layers post-date 1941 and also show intrusions into the naturally deposited sediments (Stratum II) prior to the fill episodes. The excavation results of T-041 are significant in that they supply a complete stratigraphic profile to bedrock, whereas several test excavations in the vicinity (T-023, T-024, T-025, and T-026) ended at a relatively shallow concrete slab. T-041 also provides clear evidence that the fill deposits in the vicinity post-date 1941.

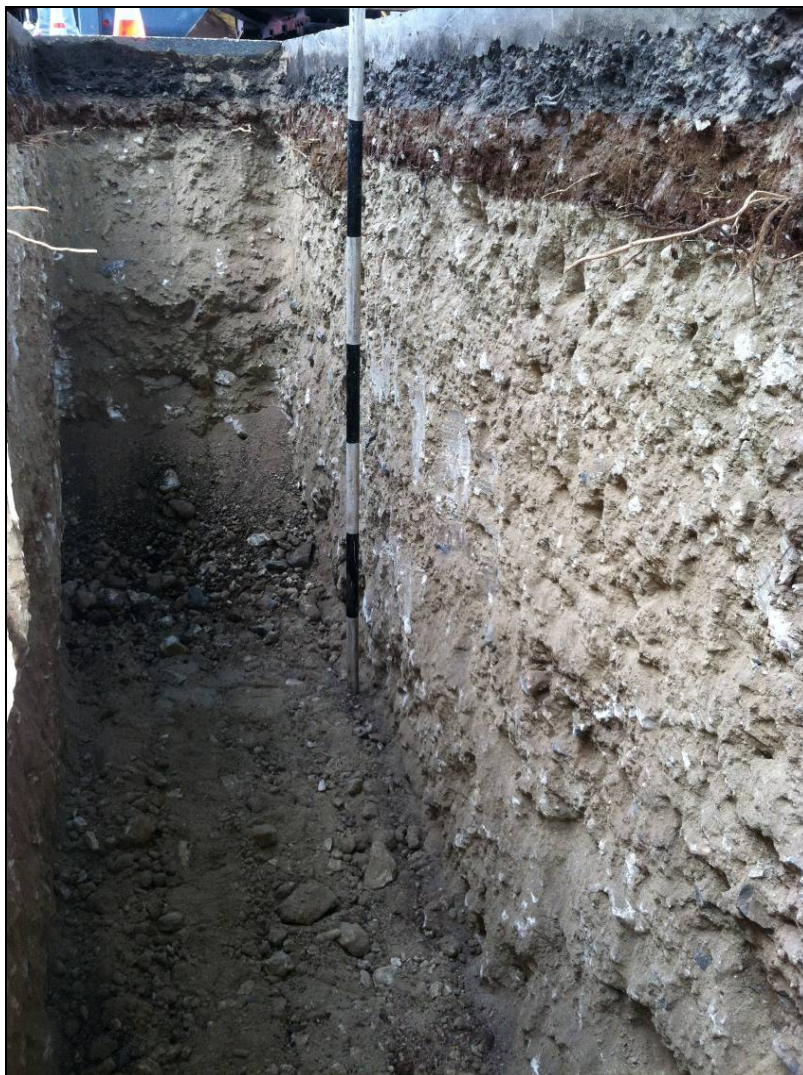
Figure 222. Photograph of Airport Section, T-043, general view of profile, view to northeast

Stratigraphic Summary: The stratigraphy, presented in Figure 222 and Figure 223, consisted of asphalt (Stratum Ia) and associated base course (Stratum Ib), very gravelly silt loam fill (Stratum Ic), very gravelly cobbly sandy loam fill (Stratum Id), loam fill (Stratum Ie), and very gravelly sandy clay fill (Stratum If). The stratigraphy conforms to the USDA soil survey designation of Fill Land (FL) No natural sediment was encountered.

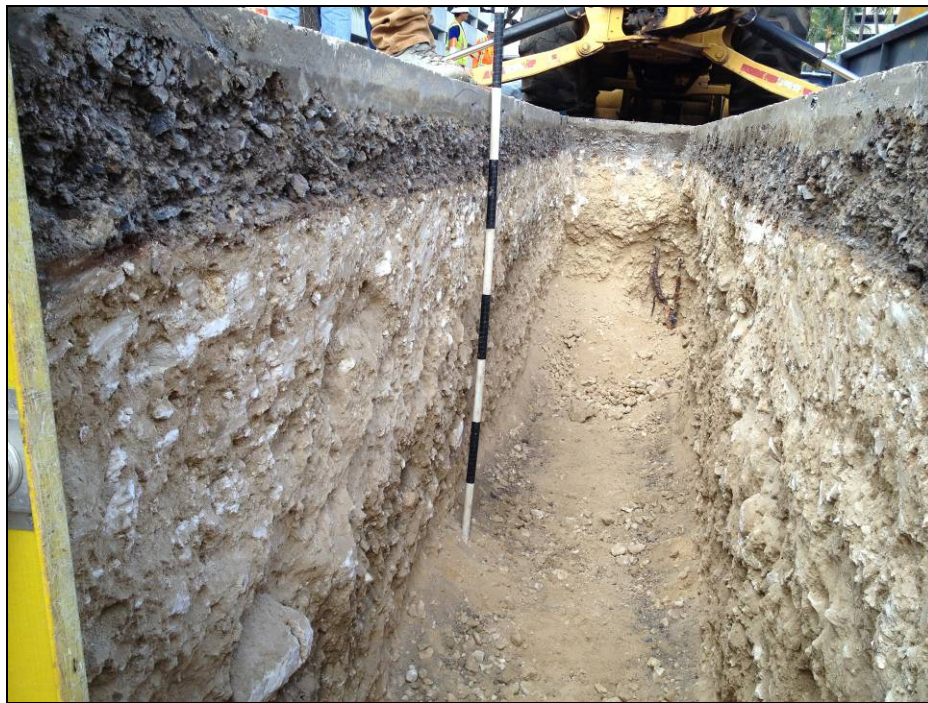
Figure 225. Photograph of Airport Section, T-044, general view of profile, view to southwest

Stratigraphic Summary: The stratigraphy, presented in Figure 225 and Figure 226, consisted of asphalt (Stratum Ia) and associated base course (Stratum Ib), and crushed coral fill (Stratum Ic and Id) overlying decomposing bedrock (Stratum II). The stratigraphy conforms to the USDA soil survey designation of Fill Lands (FL).

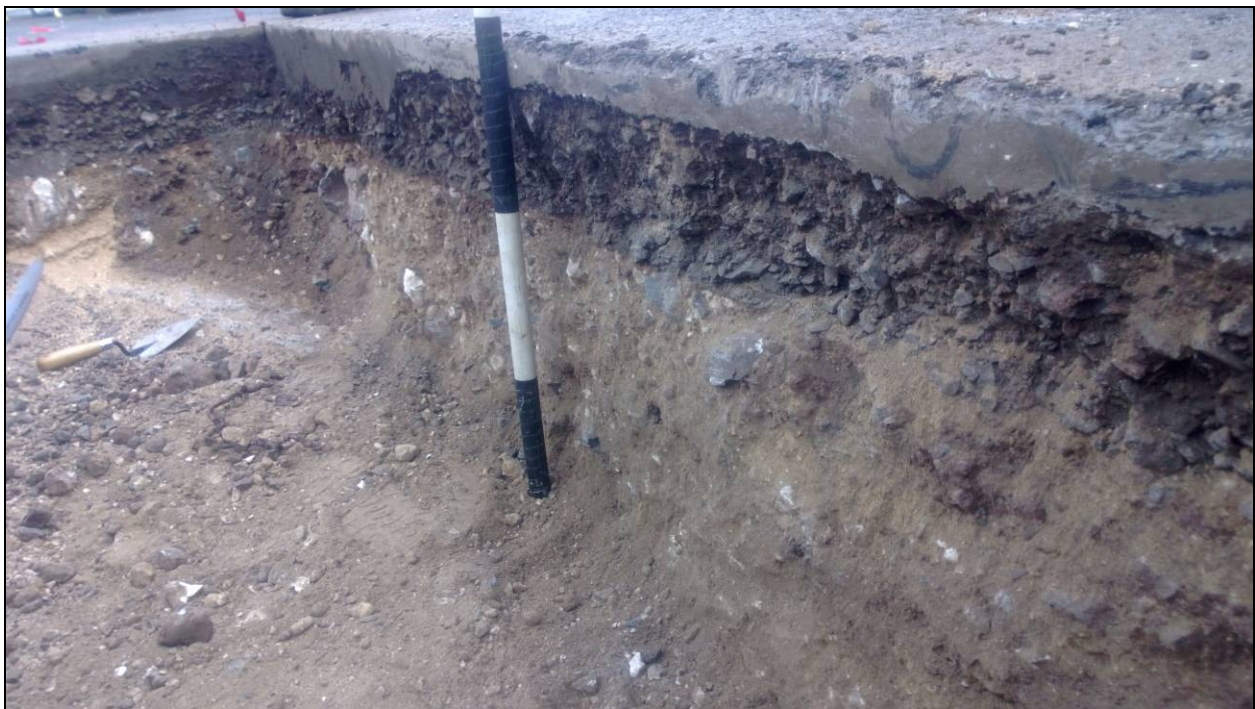
Figure 228. Photograph of Airport Section, T-045, general view of profile, view to northwest

Stratigraphic Summary: The stratigraphy, presented in Figure 228 and Figure 229, consisted of asphalt (Stratum Ia), associated base course (Stratum Ib), and crushed coral fill (Stratum Ic) to the base of excavation. Excavation was halted due to the utilities that were encountered. The stratigraphy conforms to the USDA soil survey designation of Fill Lands (FL).

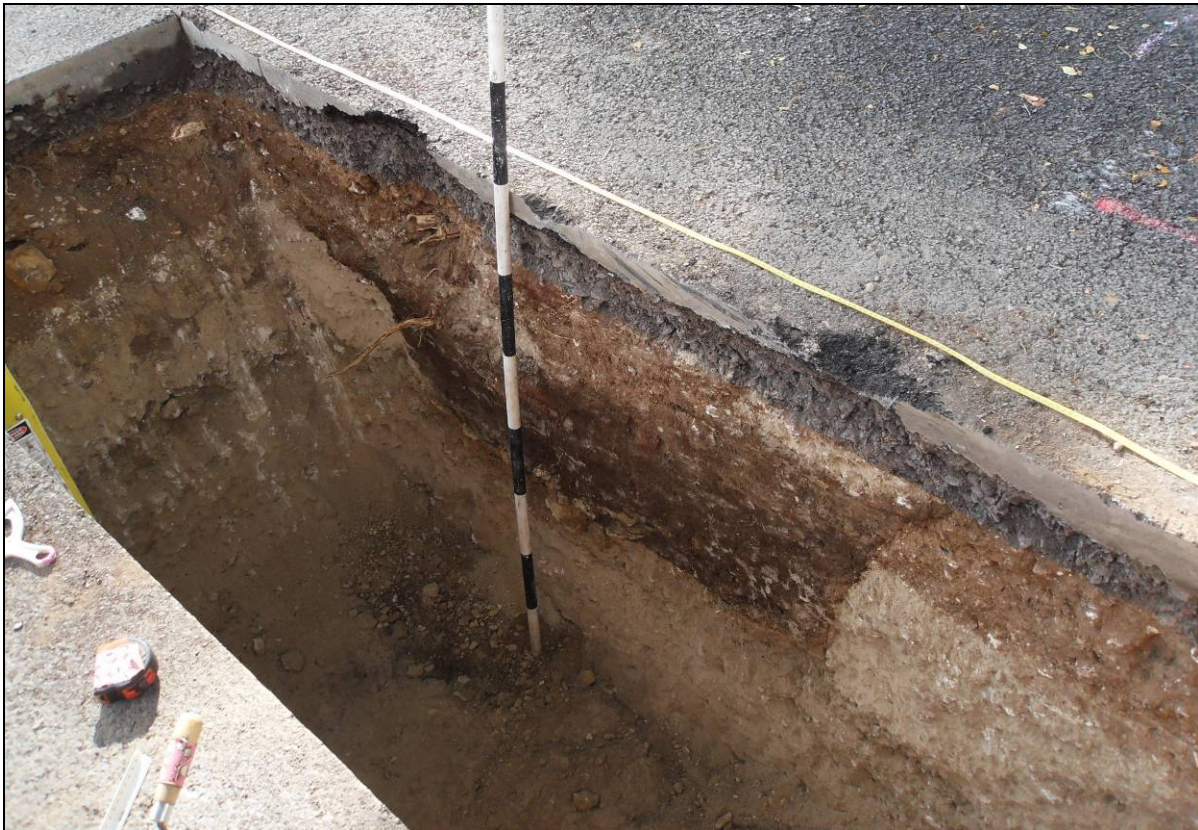
Figure 231. Photograph of Airport Section, T-046, general view of profile, view to south

Stratigraphic Summary: The stratigraphy, presented in Figure 231 and Figure 232, consisted of asphalt (Stratum Ia) and associated base course (Stratum Ib), possible landscaping fill (Stratum Ic), crushed coral fill (Stratum Id), gravelly silty clay loam fill (Stratum Ie) crushed coral fill (Stratum If and Ig), gravelly sandy clay loam fill (Stratum Ih), a buried concrete slab (Stratum Iia), a buried asphalt pavement (Stratum Iib) and associated base course (Stratum Iic), and very

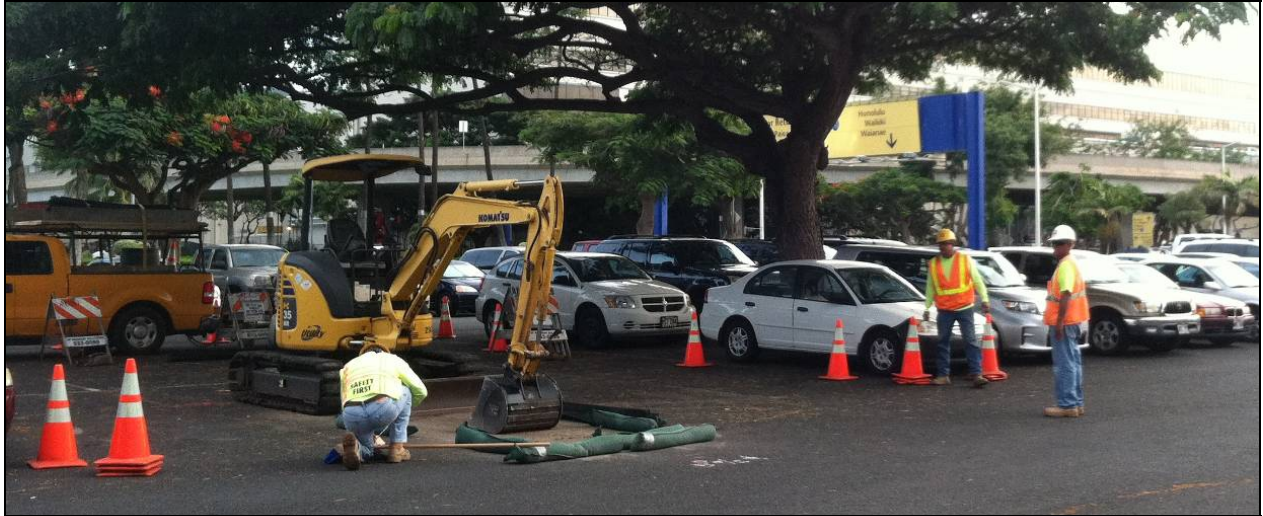
Figure 233. Photograph of Airport Section, T-047, general location, view to northeast

Setting: Test Excavation 47 (T-047) was located in the airport parking lot just east of the exit lanes, off of Ala Onaona Street (see Figure 142 and Figure 233). The area is fairly level with the surrounding land surface.

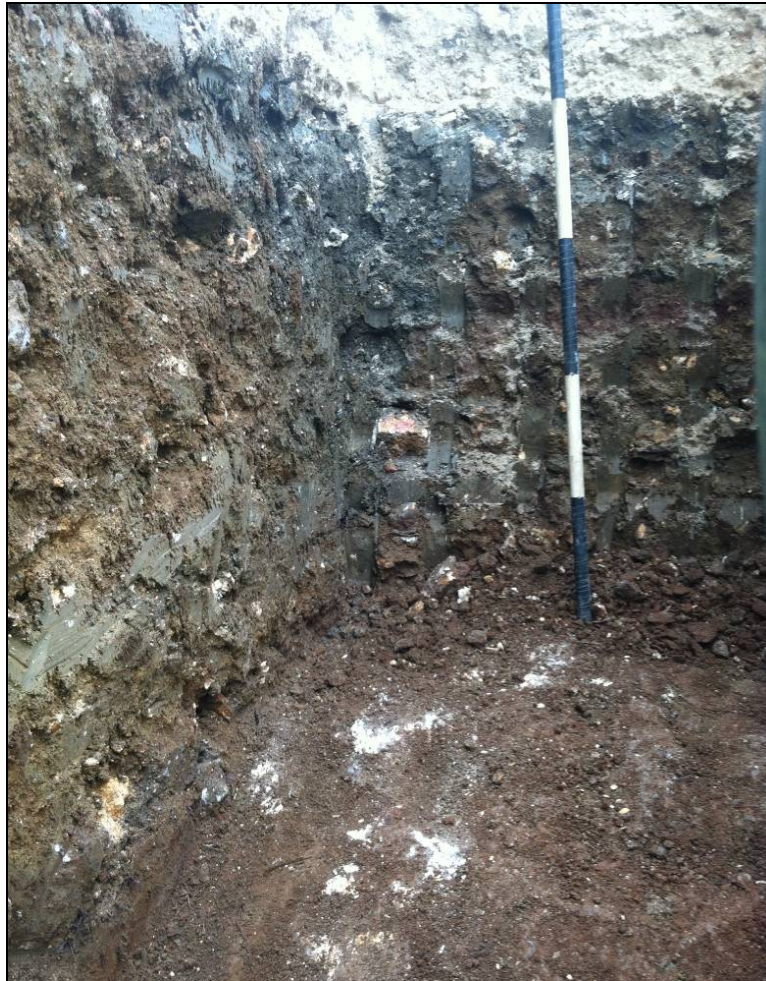
Figure 234. Photograph of Airport Section, T-047, general view of profile, view to southeast

Stratigraphic Summary: The stratigraphy, presented in Figure 234 and Figure 235, consisted of asphalt (Stratum Ia) and associated base course (Stratum Ib), very gravelly sandy loam fill (Stratum Ic), and very gravelly loam fill (Stratum Id) overlying natural silty clay loam (Stratum II) to the coral shelf. The stratigraphy generally conforms to the USDA soil survey designation of Fill Land (FL), however, natural sediment (Stratum II) was encountered at 155 cmbs.

Summary: The stratigraphy of T-047 consisted of asphalt (Stratum Ia) and fill (Stratum Ib to Id) overlying natural silty clay loam (Stratum II) to the coral shelf. The stratigraphy generally conforms to the USDA soil survey designation of Fill Land (FL), however, natural sediment (Stratum II) was encountered at 155 cmbs. No cultural resources were identified.
